# **Hazardous Building Materials Assessment**

**St. Thomas More School**

**Plan Number: 023006**

**Subject:** Hazardous Building Materials Assessment

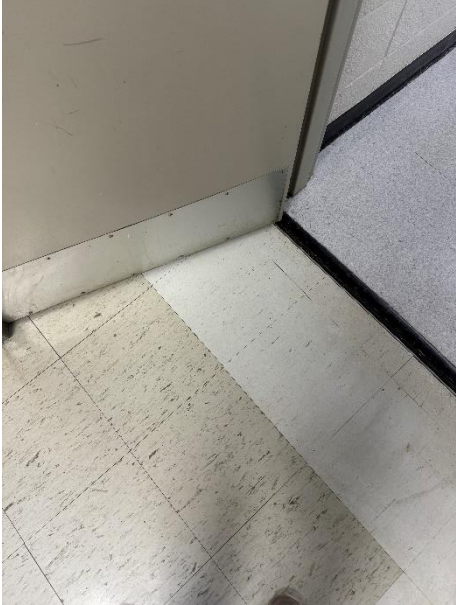
| <p>North Hallway / Asbestos Vinyl Floor Tile (speckled beige)</p> | <p>Room 31 North Block Wall / Asbestos Vermiculite Insulation</p> |

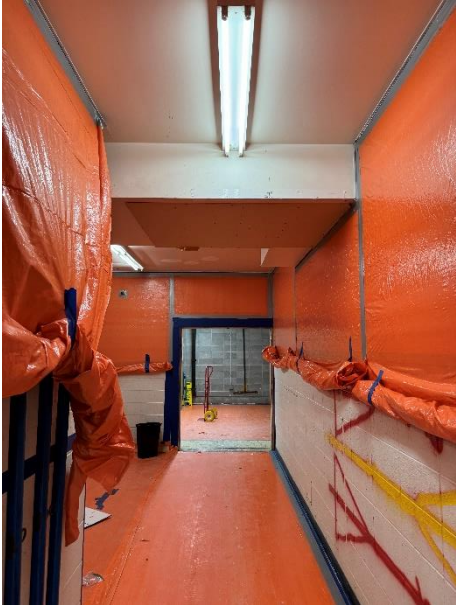
| <p>Gym Storage Room 1 / Asbestos Drywall Joint Compound</p> | <p>South Resource Room / Asbestos Vinyl Floor Tile (green and grey)</p> |

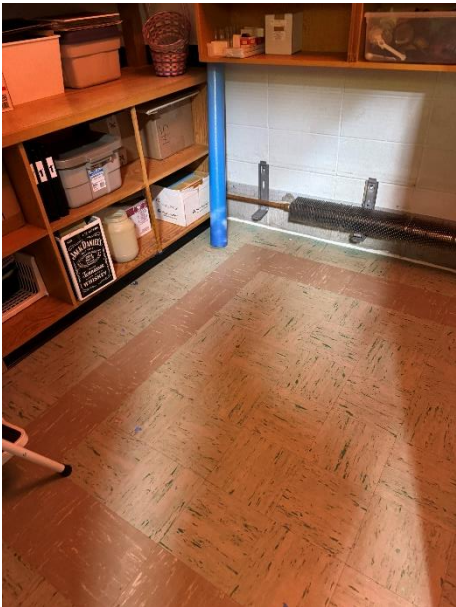
| <p>Room 13 / Asbestos Vinyl Floor Tile (light green)</p> | <p>Room 7 East Block Wall / Asbestos Vermiculite Insulation</p> |

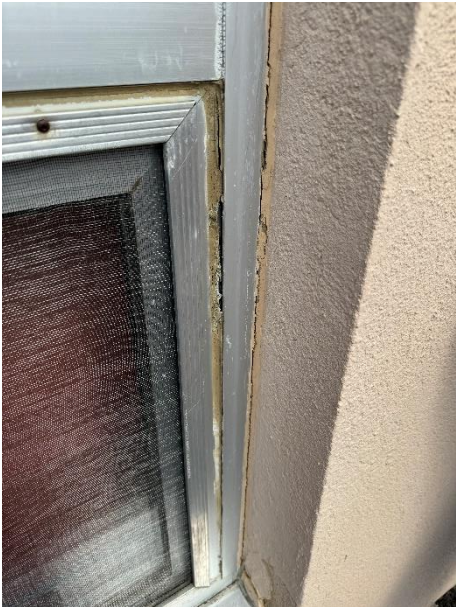
| <p>Exterior East Window Caulking / Asbestos Window Caulking (grey)</p> | <p>Exterior Southeast Window Caulking / Asbestos Window Caulking (grey/brown)</p> |

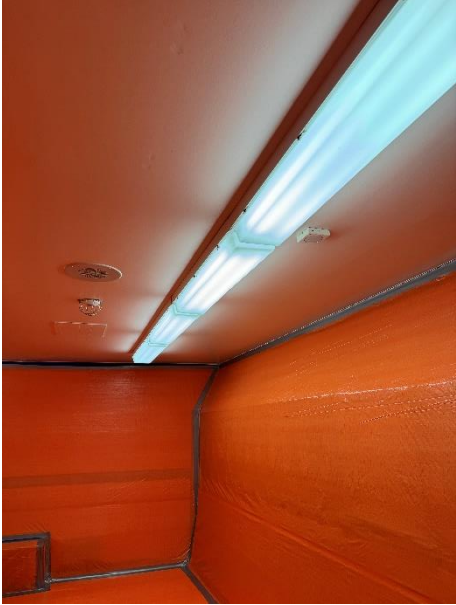
| <p>Gym Girl's Changeroom / Asbestos Drywall Joint Compound (assumed)</p> | <p>Gym Boy's Changeroom / Asbestos Drywall Joint Compound (assumed)</p> |

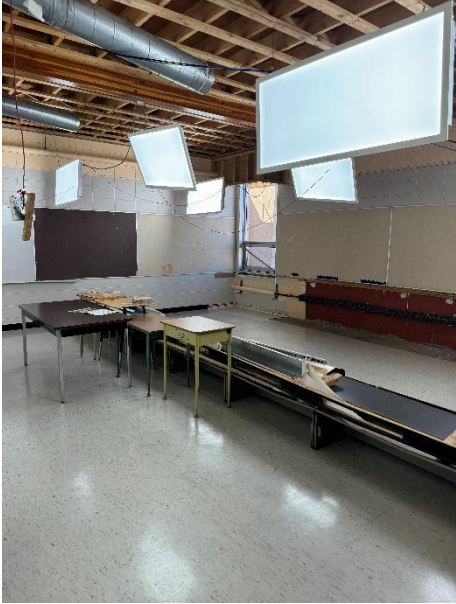
| <p>Room 27 / Asbestos Vinyl Floor Tile (speckled beige)</p> | <p>Foods' Lab Storage Room / Asbestos Vinyl Floor Tile (speckled beige)</p> |

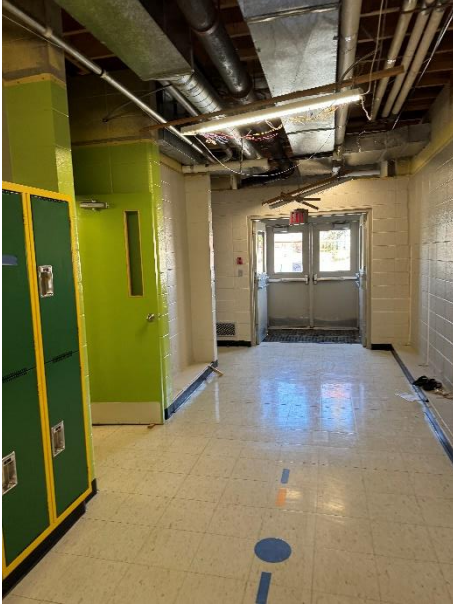
Northwest Hallway / Asbestos Vinyl Floor Tile  
(speckled beige)

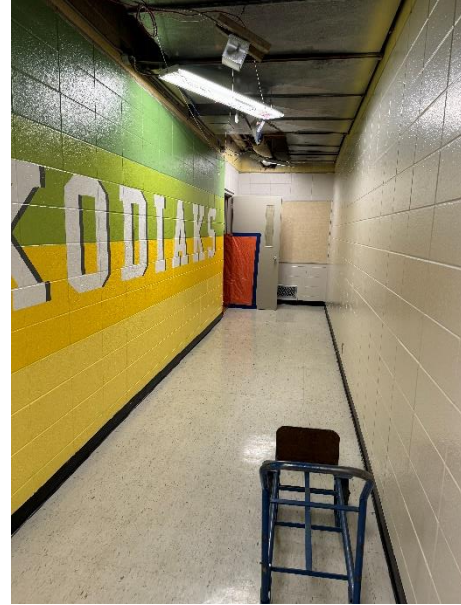
West Stage Hallway / Asbestos Vinyl Floor Tile  
(speckled beige)

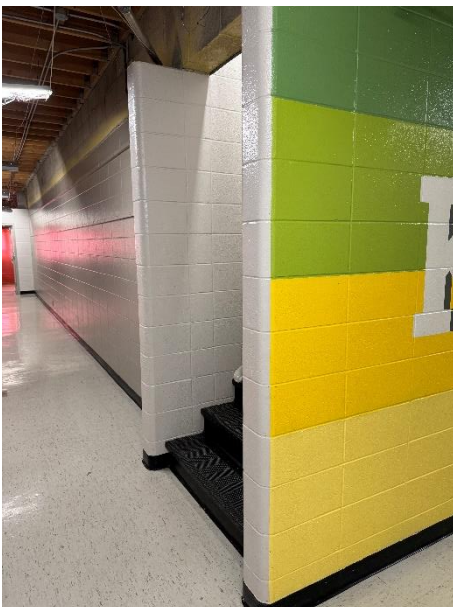
Southwest Hallway / Asbestos Vinyl Floor Tile  
(speckled beige)

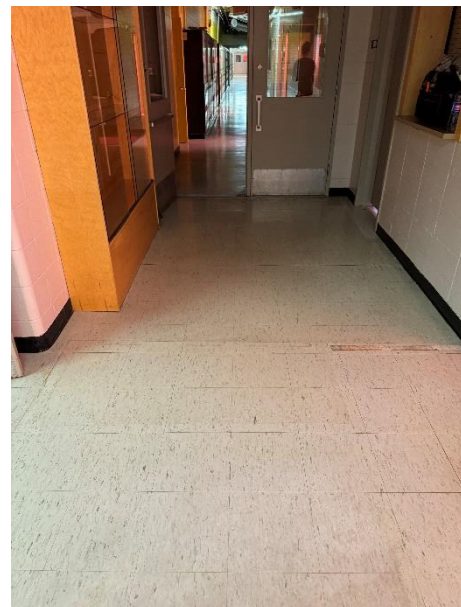
Southwest Hallway Foyer / Asbestos Vinyl Floor  
Tile (speckled beige)

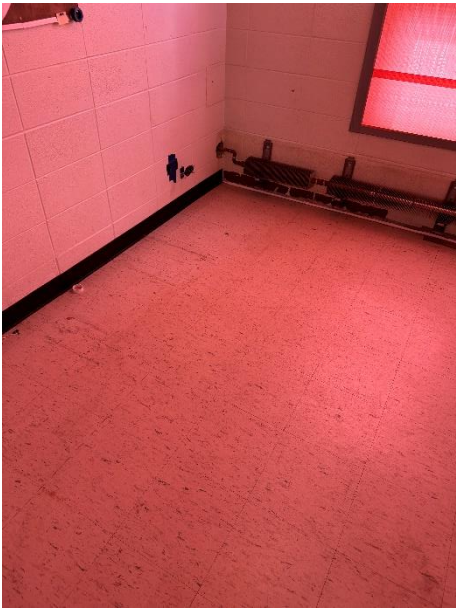
| <p>Room 10 / Asbestos Vinyl Floor Tile (speckled beige)</p> | <p>Room 9 / Asbestos Vinyl Floor Tile (speckled beige)</p> |

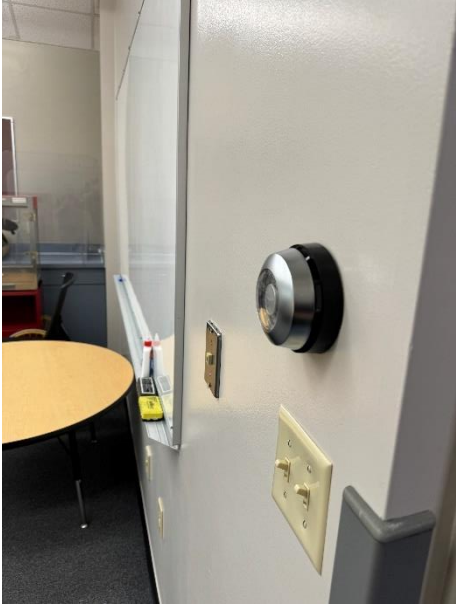
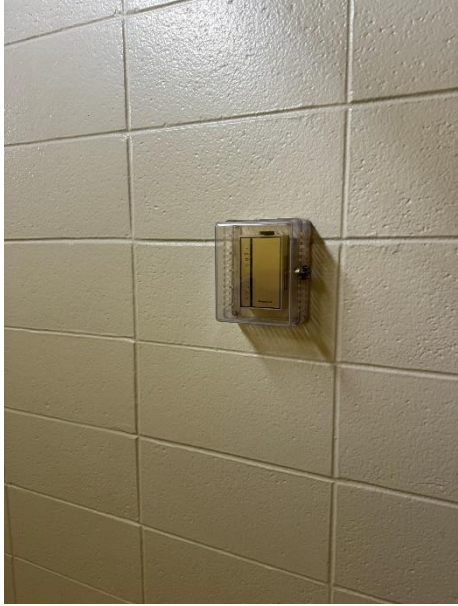
Approximately eighteen (18) suspected mercury-containing thermostats were observed throughout the school.

| <p>Typical Mercury Thermostat (throughout)</p> | <p>Typical Mercury Thermostat (throughout)</p> |
