# Facility Condition Assessment (FCA) Report

**St. Thomas More Catholic School**

**10208 – 114 Street Fairview, AB.**

**June 19, 2024**

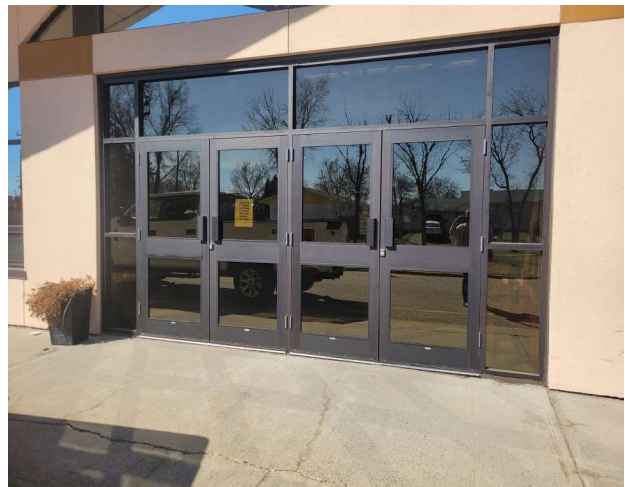
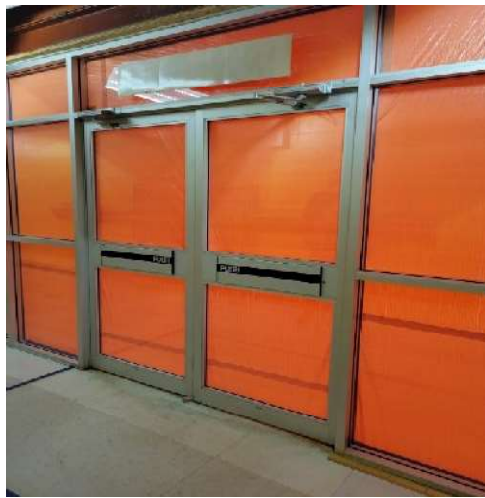
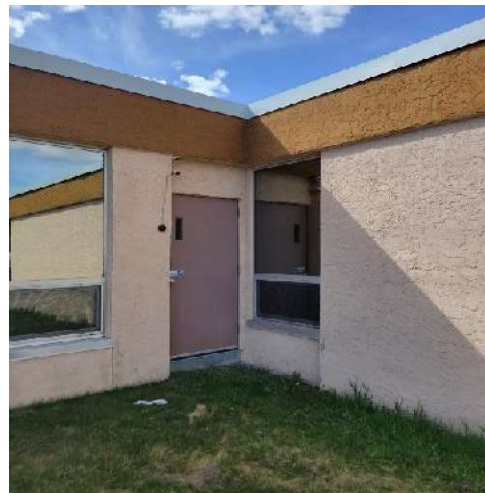
Aluminum-Framed Storefronts

| Unifomat # | Name | Year Installed | Description | Rating (A-F) | Life Expectancy (<5, 5-10, >10) | Summary of Concerns (Code, Life Safety, Repair, Replacement) | Recommendations | Estimated Quantity | Unit | Unit Cost | Estimated Cost to Upgrade | Priority (H, M, L) |
|---|---|---|---|---|---|---|---|---|---|---|---|---|
| B2031.01* | Aluminum-Framed Storefronts: Doors | 1989 | Aluminum framed storefront doors are provided on the east elevation (main entrance). The doors are double swing and are completed with matching transom and sidelights. Door count includes vestibules doors. | C | <10 | Doors are at the end of the intended lifecycle, and will require significant maintenance. | Replace aluminum storefront doors. | 4 | each | \$14,000.00 | \$56,000.00 | M |

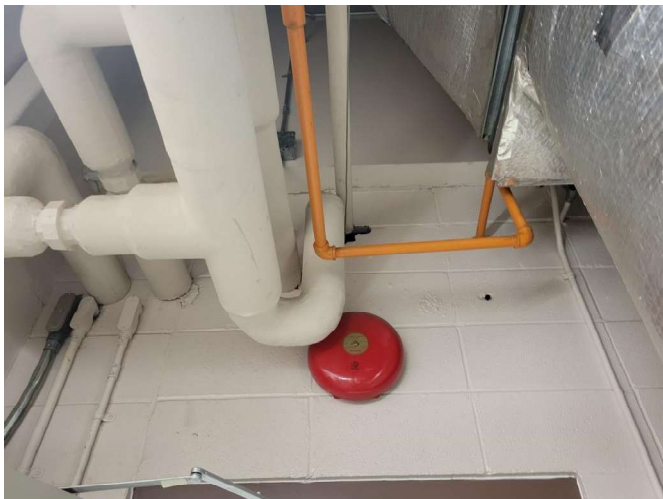
Interior Partition Firestopping

No firestopping was found at wall penetrations in fire rated walls, such as service rooms and storage rooms.

During the walk-through, no firestopping was found at penetrations in fire rated walls at any locations in the school, and this needs to be corrected as a top priority.
