# Facility Condition Assessment (FCA) Report

**St. Thomas More Catholic School**

**10208 – 114 Street Fairview, AB.**

**June 19, 2024**

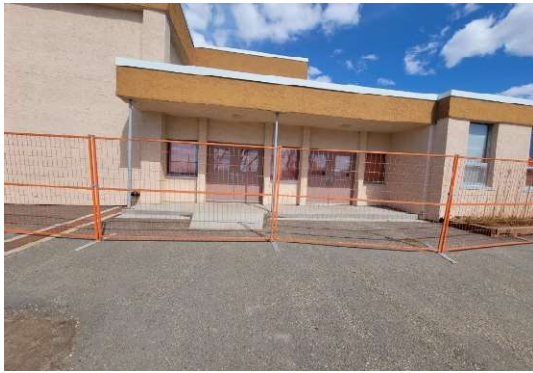
Limited concrete stairs around the site.

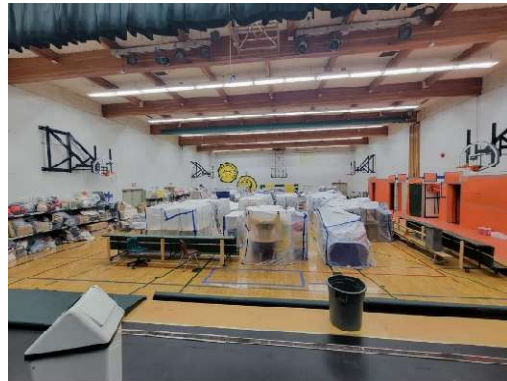
Gym glulam structure

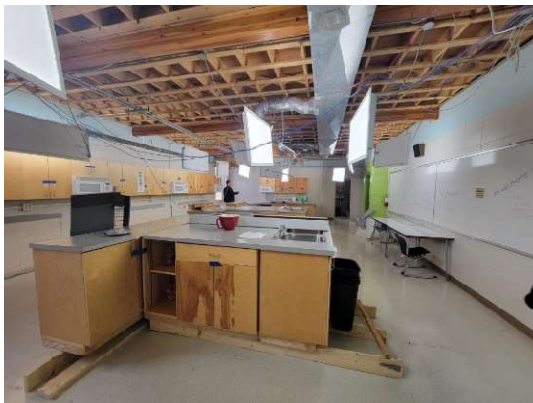
Typical 1962 & 1967 wood structure.

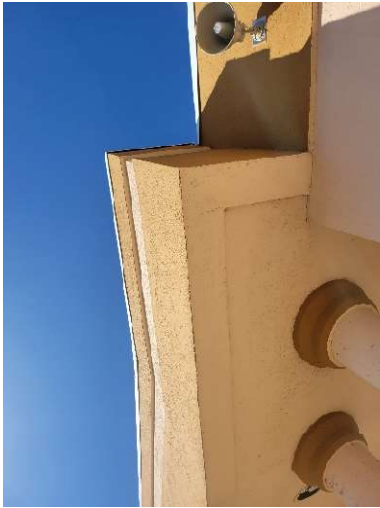
Underside of soffits are finished with stucco.
