# Facility Condition Assessment (FCA) Report

**St. Thomas More Catholic School**

**10208 – 114 Street Fairview, AB.**

**June 19, 2024**

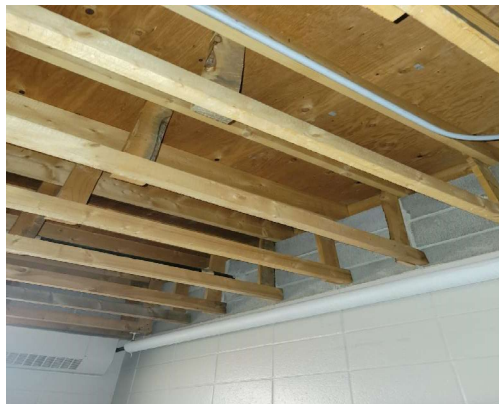
1962 & 1967 wood structure.

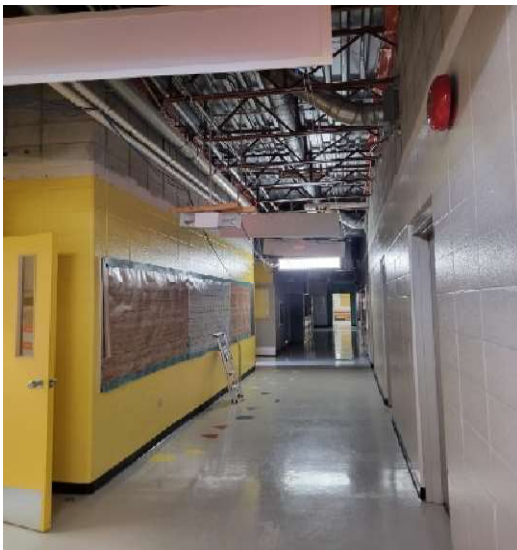
Typical 1989 OWSJ
